A DAMAGING SEAQUAKE

N. AMBRASEYS

Department of Civil Engineering, Imperial College of Science & Technology, London, England

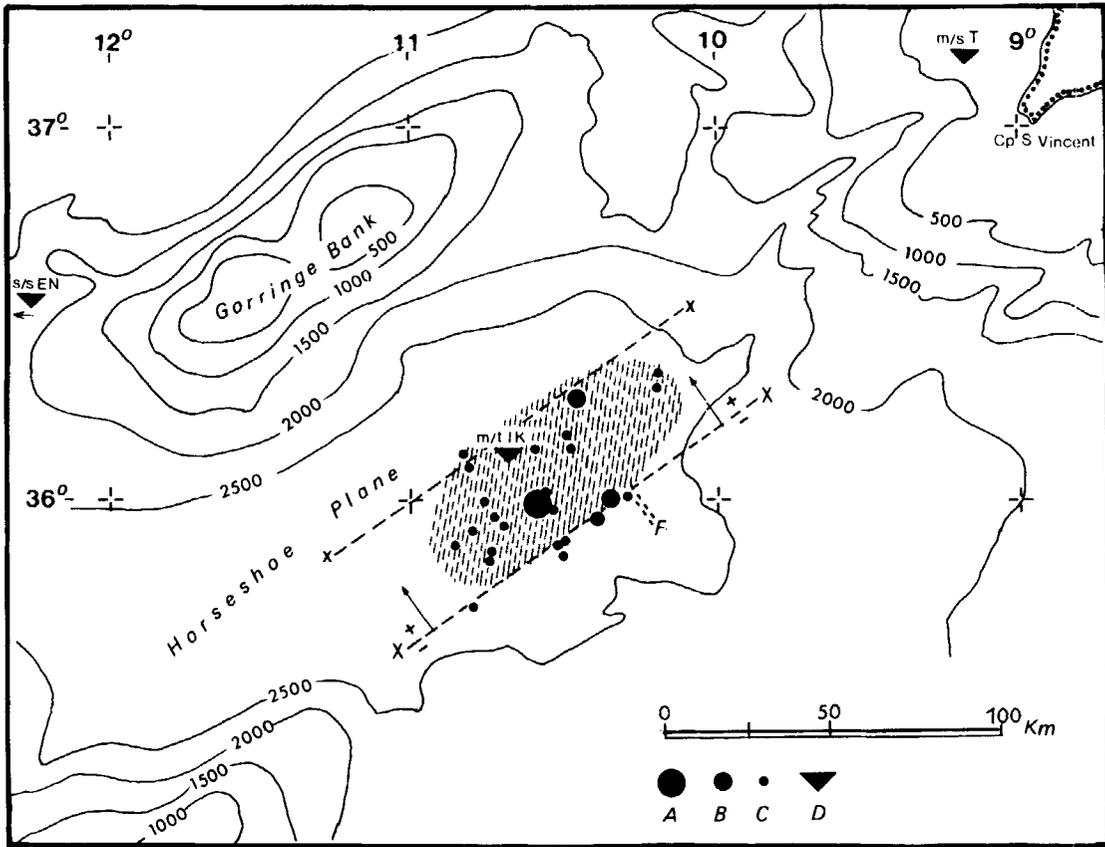
All this was apparently the result of an earthquake at 02 h 40 mm 33 s (GMT) with an epicentre offshore of Gibraltar at 35·97°N–10·59°W (ISC normal depth determination), i.e. 20 km from where the ship was damaged. No other ships are known to have been in the near-field of this major earthquake ($M_s = 7·8$, $M_0 = 6·0 \times 10^{27}$ dyn-cm).² A number of vessels further away, Figure 1, particularly those sailing along the

Figure 1. Map of epicentral region of the earthquake of 28 February 1969 (based on Fukao²), showing bathymetry (in fathoms). A: main shock, and the distribution of the aftershocks, B: $5.0 \leq m$ and C: $m \leq 4.0$ (ISC determinations); X-X indicates the surface strike direction and upthrust (+) block; hatchings show projection of assumed fault plane. D: position of ships that reported the main shock (four more vessels north of m/s 'T', not shown). F: approximate location and trend of secondary escarpment⁵

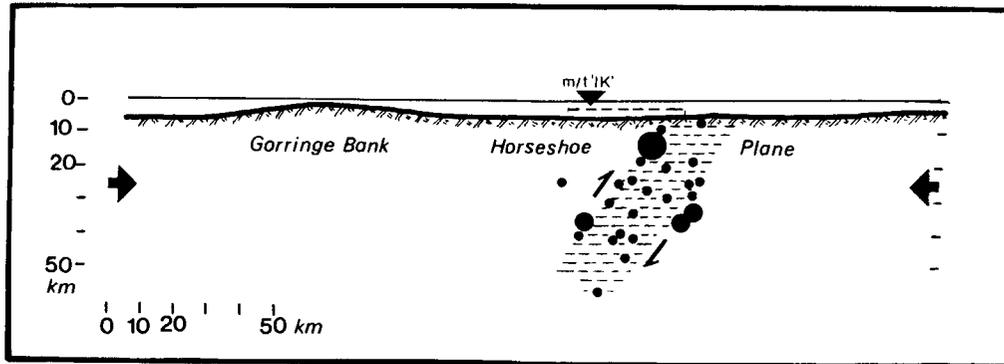
Figure 2. Cross-section of aftershock distribution and bathymetry along a profile at right angles to X-X in Figure 1. Dashed line under m/IK shows diagrammatically assumed motion of sea bottom (X-X to x-x) during the event. Convention of symbols as for Figure 1. Focal depths of the aftershocks used in this projection are from the International Seismological Centre (ISC). The main reason for preferring the northwest dipping plane of Fukao's solution² is that it can lead to the formation of the Gorringe Bank⁷

are common in the hanging wall block of thrust faults, which often collapse by normal faulting. The superficial nature of these normal faults is revealed by their fault planes, which do not contain the seismically determined slip vector.⁶ These normal features could also be the result of slumping following the earthquake. However, the observed seamounts in this area⁷ clearly reflect crustal shortening and suggest a violent upward motion of the ocean bottom being responsible for the large overpressures experienced by the vessel.

It appears, therefore, that at the time of the earthquake 'Ida Knudsen' was in 5 km of water immediately above the central part of the 80 km long portion of the ocean bottom which was uplifted vertically by 2.0 m. Although there are not enough data to calculate the response of the ship and there is a good deal of uncertainty about the actual duration of the event, as a first approximation we may assess the overpressure generated in the near-field by assuming at $t = 0$ an infinite line of ocean bottom, coinciding with the fault-trace X-X (Figure 1), and moving up with a velocity (Z/Dt) for Dt seconds, and then stopping. Also by assuming at the same time that this line X-X moves away from the trace in the direction of the dip with a velocity c ($c > a =$ speed of sound in water), acting as a trigger for the vertical motion (Z) , and stopping at x-x, Figure 1. For this earthquake the rise time has been estimated at 6.2 s⁸ for a 2.0 m vertical displacement of the upthrust block so that we may take $Z/Dt = 33$ cm/s. Concentrating on near-field transient effects, i.e. disregarding the decay of the pressure pulse due to waterflow to restore hydrostatic equilibrium and the reverberation of the water layer, by assuming $c = 3.0$ km/s, it can be shown⁹ that the overpressure in the near-field should be about 6.0 atm. If we take $Z/Dt = 100$ cm/s which accounts for stopping phases for a rise time of 2 s, the overpressure should be 17 atm. This transient overpressure, which is well over design limits for vessels such as 'Ida Knudsen', should have been produced over a large region of the ocean, comparable to the linear dimensions of the dislocated crust of about 50 km, and it was probably responsible for the observed buckling and instability of structural members of the vessel. On the whole, in spite of the great variability of the quantities that enter into the calculations, the results from this particular case, for which we considered only one type of motion as a contribution to the acoustic wave in the water with no quantification of the response of the ship, are of interest because they illustrate some of the factors to be considered in the relatively rare event of hydrodynamic loading of ships and of offshore structures due to the sudden deformation of the sea bottom associated with large earthquakes. For a pressure-time variation of a 10-atm pulse of 0.5 s duration, it can be shown¹⁰ that a 25 mm thick steel plate of the bottom shell of the vessel will be shifted inwards by about 50 cm. The damage that will result from such a pulse will be due to the presence of stiff bracings. In the present case the vessel appears to have behaved in an asymmetric way, in a situation where one would expect the applied overpressure to be uniform within the dimensions of the ship. The bow is reported as rising more than the stern. Is it possible that the earthquake overpressures detonated a large quantity of dumped explosives to give results rather like the impact of a large explosion? There are places, like the Hurd Deep, for example, where enormous quantities of explosive have been dumped at one time or another.¹¹
